LAKE SEMINOLE ALUM PROJECT MAY 28, 2009 SITE VISIT PICTURES

The Construction Phase of the Lake Seminole alum project is in progress. For the in-lake treatment area (Basin 1) on the northern-most part of the lake, the contractor is close to completing the installation of the permanent sheet piles and is dredging the area confined by the sheet piles to add capacity to the treatment area. Construction of the trough for the Bypass Canal treatment area is also proceeding.

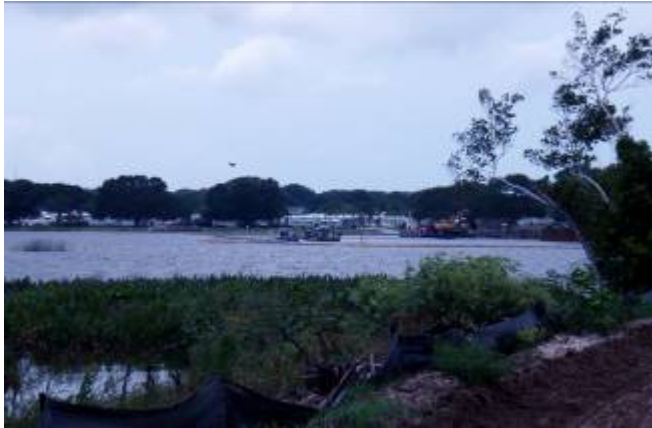
1. The in-lake alum treatment area, looking northwest. The suction dredge barge is in the center of the picture. To the right, the excavator can be seen removing the dredged sediment from the temporary settling area.

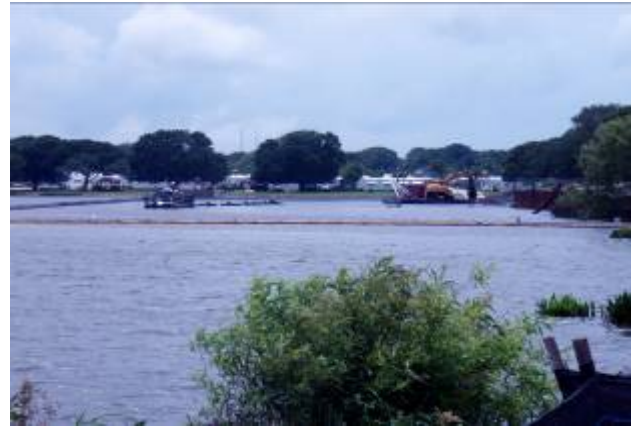
2. The in-lake alum treatment area, looking west. The suction dredge barge is on the left side of the picture. To the right, the excavator can be seen removing the dredged sediment from the temporary settling area.

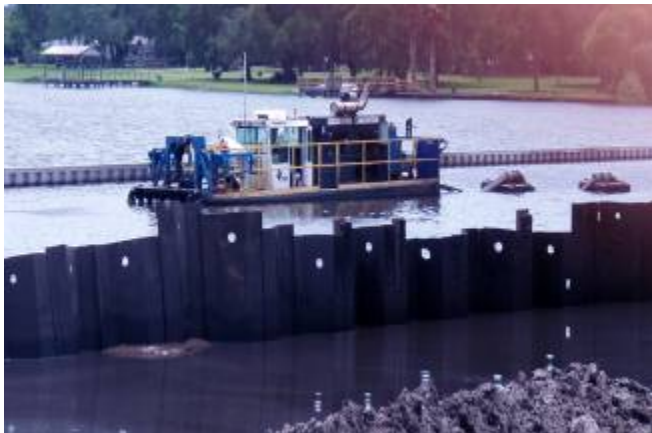
3. The in-lake alum treatment area, looking southwest. In the foreground is the temporary sediment settling area. In the background is the suction dredge barge.

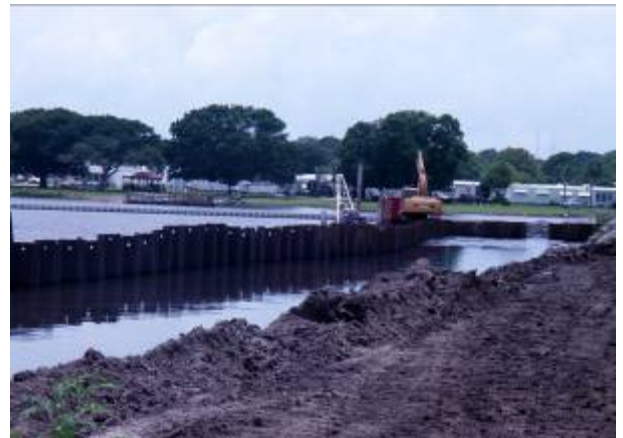
4. The in-lake alum treatment area, looking west, during the dredging process. In the foreground is the temporary sheet pile for the settling area. In the background is the excavator removing previously dredged sediment from the settling area.

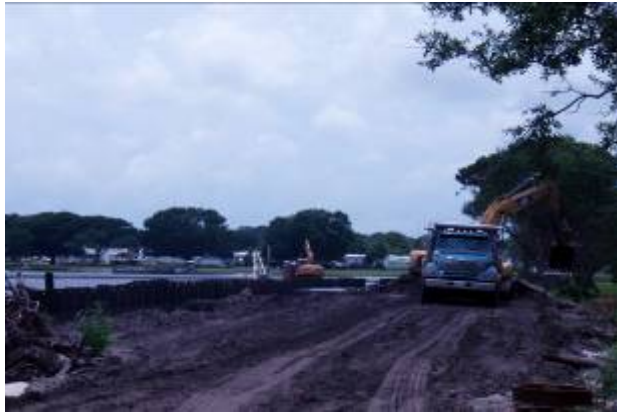
5. The in-lake alum treatment area, looking west over during the dredging process. Dredged material is being loaded onto a truck to be transported to the drying area and then later removed.

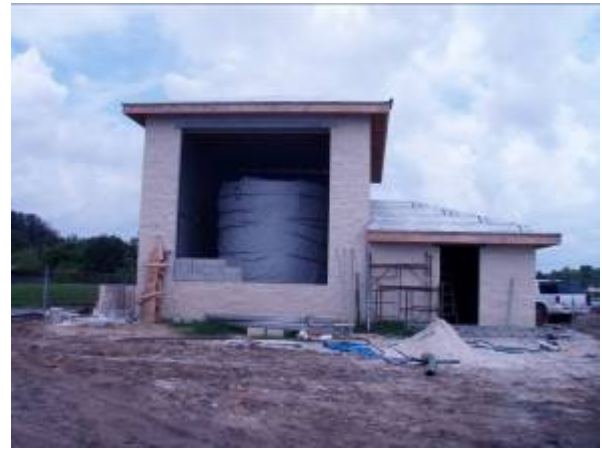
6. Looking east at the alum storage building which will provide alum to both the in-lake and bypass canal treatment systems.

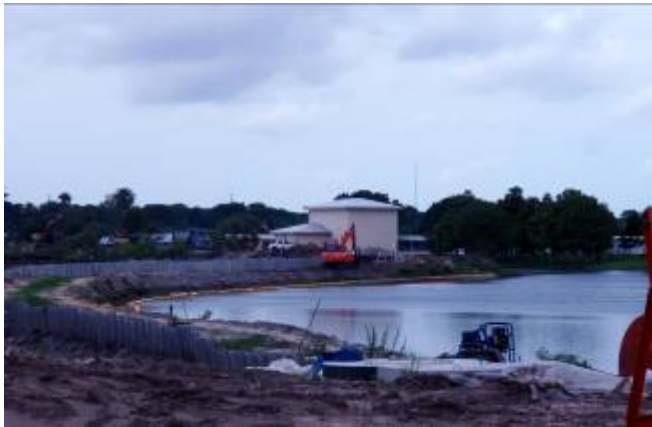
7. Bypass canal treatment trough, looking northwest. In the foreground is the treatment trough that will flow to the southeast from near the alum building in the background.

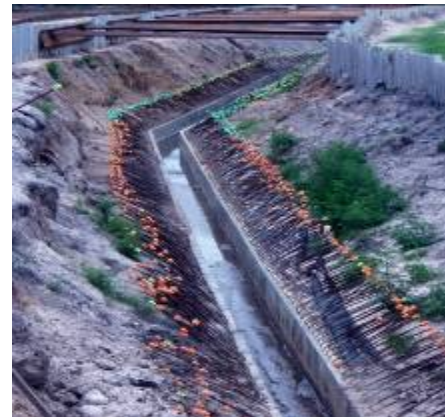
8. Bypass canal treatment trough, looking west. This system is designed to allow the treated water to flow through the trough and have the sediment fall out before the cleaned water is returned to the lake or canal.

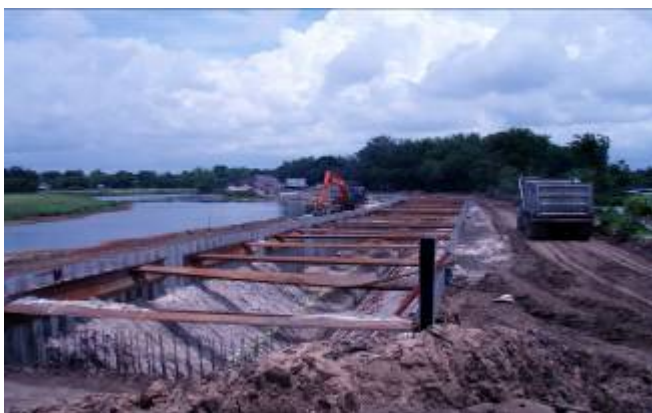
9. The bypass canal treatment trough during construction, looking east.

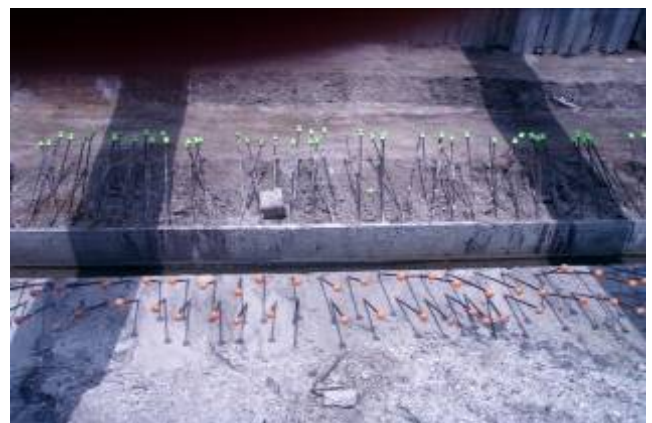
10. Looking down into a section of the bypass canal treatment trough.

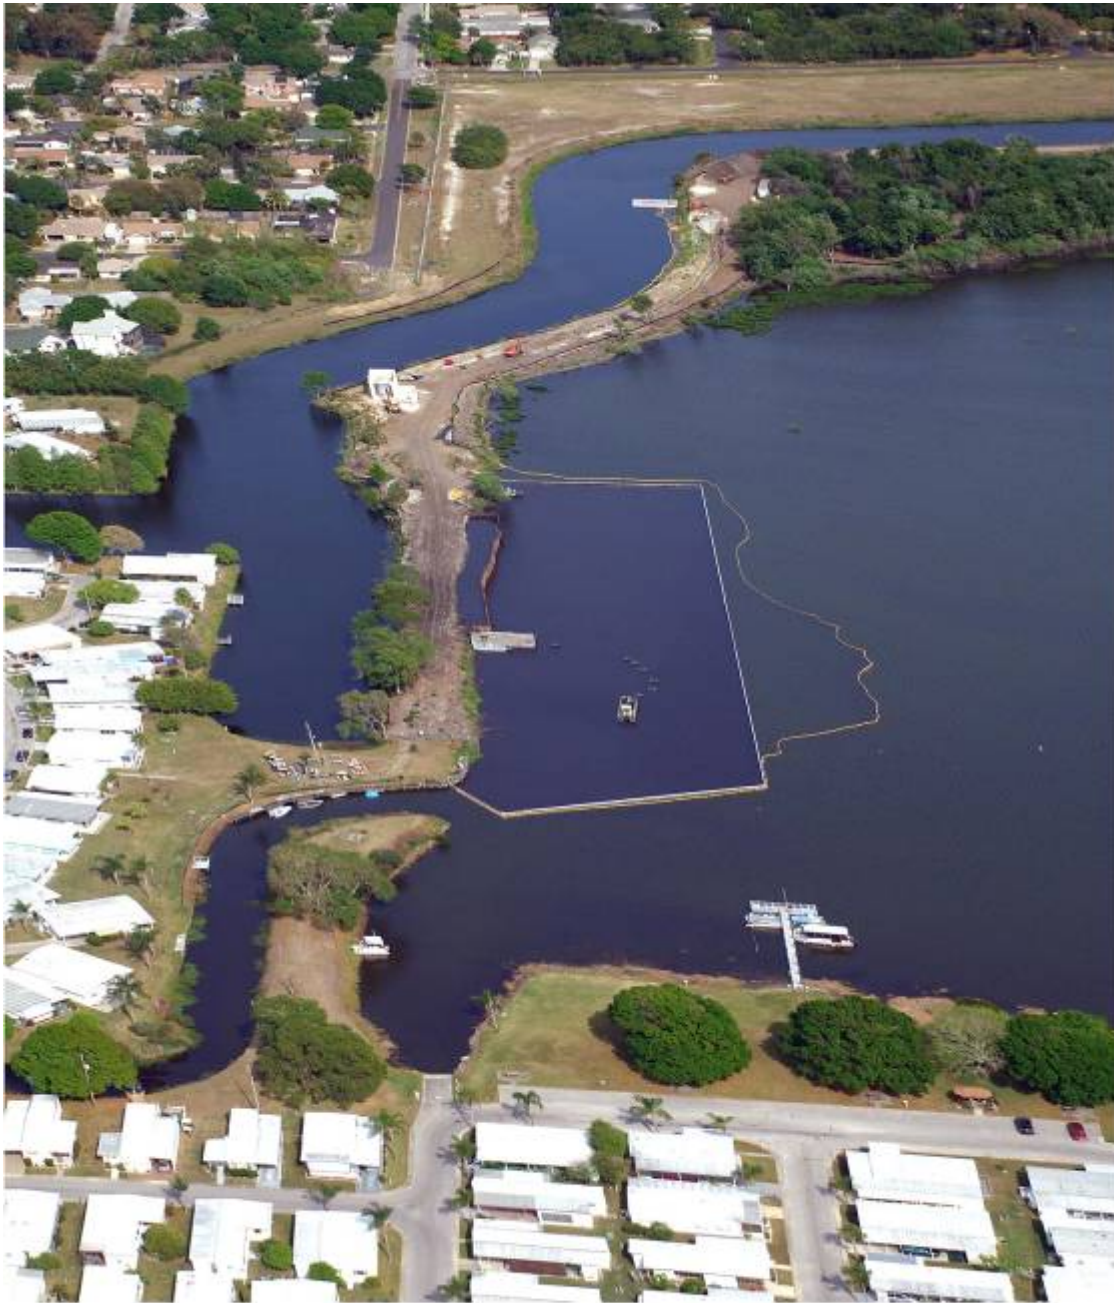
Image # 90325 2333
Date 03.25.09

11. Aerial Photograph of the project areas taken on March 25, 2009. Looking toward the east, the in-lake treatment area is in the foreground and the bypass canal treatment area is in the background. The floating turbidity-control booms can be seen surrounding the work area.
