Pinellas County Utilities  
St. Petersburg, Florida

**SOUTH CROSS BAYOU WRF  
FILTRATION SYSTEM INSPECTION**

May 9-10, 2018

De Nora Water Technologies  
Pittsburgh, Pennsylvania  
WO# 3444  
July 23, 2018

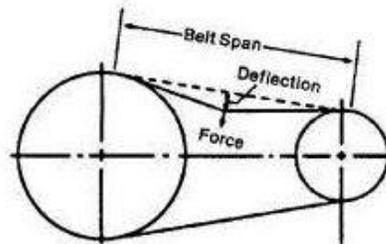
Tighten or loosen belts to bring them into the recommended range.

**Note:** The proper tension for V-belt drive is the lowest tension at which the belts won't slip under peak load conditions.

V-Belt Cross Section	Small Sheave Diameter Range (Inches)	Recommended Deflection Force (Lbs.)		
		Initial Installation	Retensioning	
			Maximum	Minimum
A	3.0- 3.4	3.3	2.9	2.2
	3.6- 4.2	3.5	3.1	2.4
	4.6- 6.0	3.7	3.3	2.5
B	4.6- 5.4	6.0	5.1	4.0
	5.6- 7.4	6.3	5.5	4.2
	8.6- 9.4	6.6	5.7	4.4
C	7.0- 8.5	13.2	11.5	8.8
	9.0-12.0	13.9	12.1	9.3
	13.0-16.0	14.6	12.6	9.7
D	12.0-15.5	26.5	22.9	17.6
	16.0-18.0	27.8	24.3	18.7
	22.0-27.0	29.1	25.6	19.6
E	17.7-23.6	39.7	34.4	26.5
	23.7-31.5	41.7	36.2	27.8
	31.6-39.3	43.7	37.9	29.1
AX	2.1- 3.4	4.4	3.7	2.9
	3.6- 4.2	4.6	4.0	3.1
	4.6- 6.0	4.9	4.2	3.3
BX	3.7- 5.4	7.7	6.6	5.1
	5.6- 7.4	8.2	7.1	5.5
	8.6- 9.4	8.6	7.5	5.7
CX	5.8- 8.5	17.2	15.0	11.5
	9.0-12.0	18.1	15.7	12.1
	13.0-16.0	19.0	16.5	12.8

V-Belt Cross Section	Small Sheave Diameter Range (Inches)	Recommended Deflection Force (Lbs.)		
		Initial Installation	Retensioning	
			Maximum	Minimum
3V	2.65- 3.35	5.5	4.8	3.9
	3.65- 4.12	6.4	5.7	4.4
	4.50- 5.60	7.5	6.6	5.1
	6.00-10.60	8.6	7.5	5.7
5V	7.10- 8.50	19.2	16.7	13.0
	9.00-11.80	23.3	20.3	15.6
	12.50-16.00	27.3	23.8	18.5
8V	12.50-16.00	50.9	44.3	34.4
	17.00-20.00	57.1	49.8	38.6
	21.20-24.80	61.3	53.3	41.4
3VX	2.20- 3.35	5.5	4.8	3.9
	3.65- 4.12	6.4	5.7	4.4
	4.50- 5.60	7.5	6.6	5.0
	6.00-10.60	8.6	7.5	5.7
5VX	4.40- 8.50	19.2	16.7	13.0
	9.00-11.80	23.3	20.3	15.6
	12.50-16.00	27.3	23.8	18.5
